Weld Solidification Cracking in a 304L Stainless Steel Water Tank

M N James ^{1,2}, L Matthews ² and D G Hattingh ²

Keywords: Solidification cracking; 304L stainless steel; weld process; weld restraint

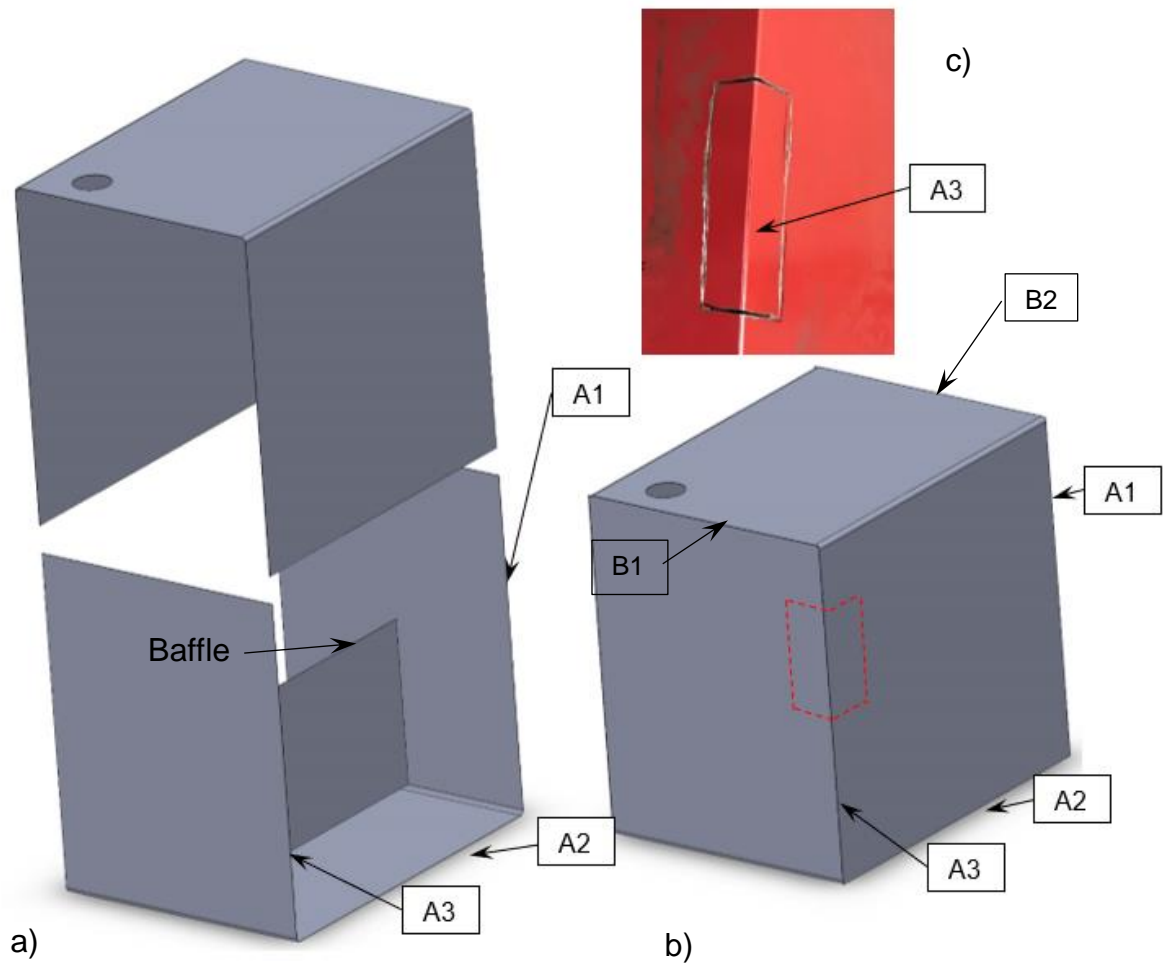
The rectangular 200 litre water tank is shown in Figure 1 and is formed by welding together two pieces of type 304L stainless steel, each bent into a 'U' shape (Figure 1a), to complete the rectangular shaped tank (Figure 1b). Horizontal dimensions in Figure 1 are 640 mm by 662 mm with a vertical height of 504 mm. Chemical composition of the 304L alloy was measured using spectroscopy and the data is given in Table 1. The alloy conforms to the specification for commercial 304L plate and it should be highly resistant to solidification cracking.

The welded seams on one side of the tank are marked with the letters 'A1' to 'A3' with the welding sequence apparently following A1 → A2 → A3. Welding on the opposite side presumably followed an equivalent sequence and closure of the tank was accomplished via welds B1 and B2. The crack origin was approximately in the centre of one of the 640 mm sides, as shown with the red dotted shape in Figure 1b and the arrow in Figure 1c. The hole shown in the top surface is where the filling valve for the tank is located and there is an internal baffle plate that extends to the half-height position. This baffle plate was tack welded on the

Figure 1 Illustrations of the water tank and its design; welding of the two sections occurred in the sequence of A1 → A2 → A3:

- a) An exploded view of the two tank sections that were bent to form 'U'-shapes and were then welded together to make the tank. The position of an internal baffle is also shown.
- b) The assembled water tank showing the position where seam cracking was found (red dotted rectangle on corner A3).
- c) The actual sample that was sectioned from the tank for further analysis.

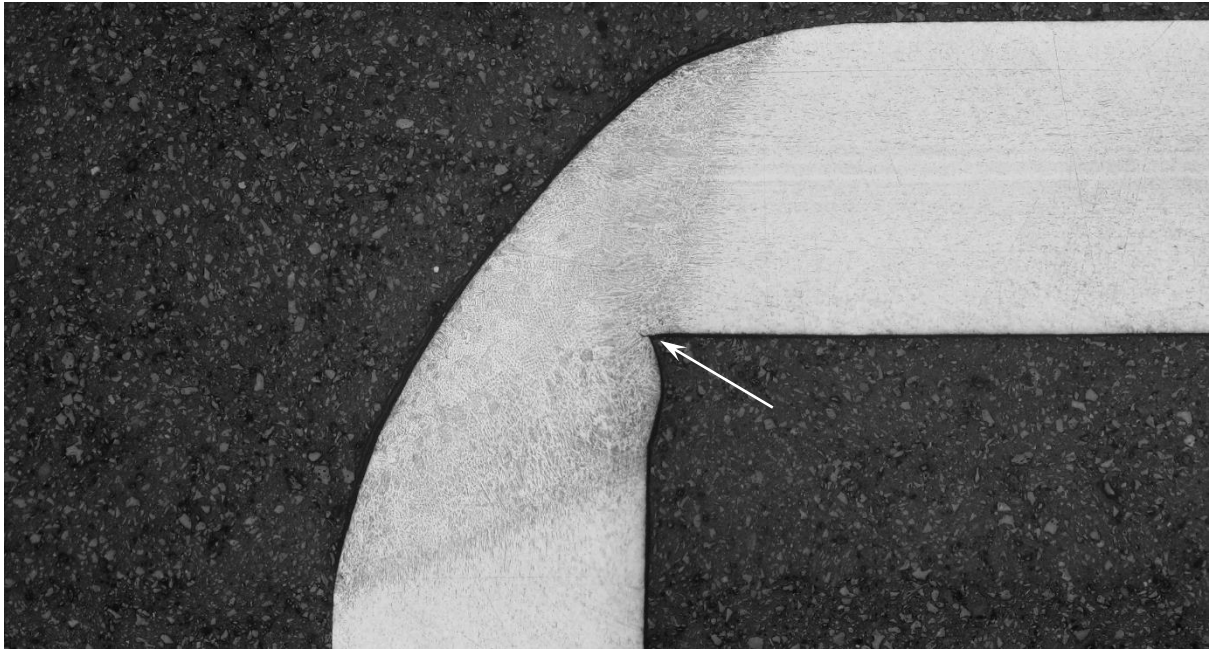
Welding was performed using a GTAW process with a type 309L filler metal (chemical composition given in Table 1). However, the tank manufacture had been subcontracted the water tank designer, and it proved to be impossible to obtain details of the welding process used. What is clear, however, is that the weld was poorly detailed in the drawings and that the process used was inappropriate in at least some of the details. The weld crown was subsequently ground to provide a smooth transition before painting the tank (see Figure 2).

A piece of the weld seam, some 200 mm in length, that contained the complete fracture was sectioned from the failed joint (shown in Figure 1c). An adjacent piece was also cut out to allow measurement of the reduction in plate cross-section arising from the corner grinding. Figure 2 shows that this cosmetic attention to detail reduced the metal thickness at the critical weld root position, which coincides with the presence of a small crack, from 2.04 mm to 1.34 mm, equivalent to a reduction of 34%. The sharp weld root and its associated defect is shown at higher magnification in Figure 3. The defect has a total length of around 100 μm . It started from a partial penetration defect (A), and comprises a sharp weld toe intrusion (B) and a final section of cracking that occurred during welding (C). The blue and straw yellow temper colours seen in Figure 4 prove that the initial crack extension occurred during welding and that it is therefore due to an embrittlement problem. Figure 3 indicates that the cracking occurring during welding was assisted by the presence of a sharp weld toe intrusion resulting from undercut at a partial penetration weld.

Figure 2 Macro-etched section of the seam weld that cracked, showing the reduction in thickness at the critical region where there is a small weld root crack (marked with the arrow).

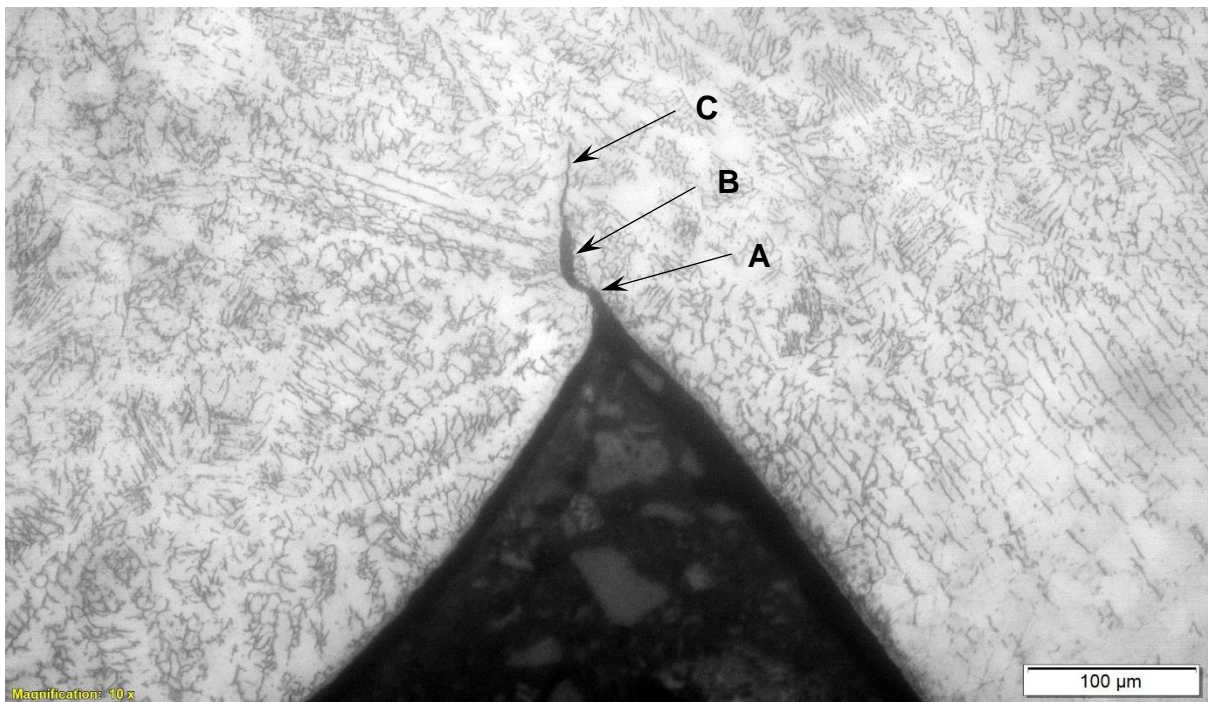
Figure 3 Higher magnification image of the weld root crack induced during welding. The crack has a total length of around 100 μm . It starts from a partial penetration defect (A), and comprises a sharp weld toe intrusion (B) and a final section of solidification cracking (C).

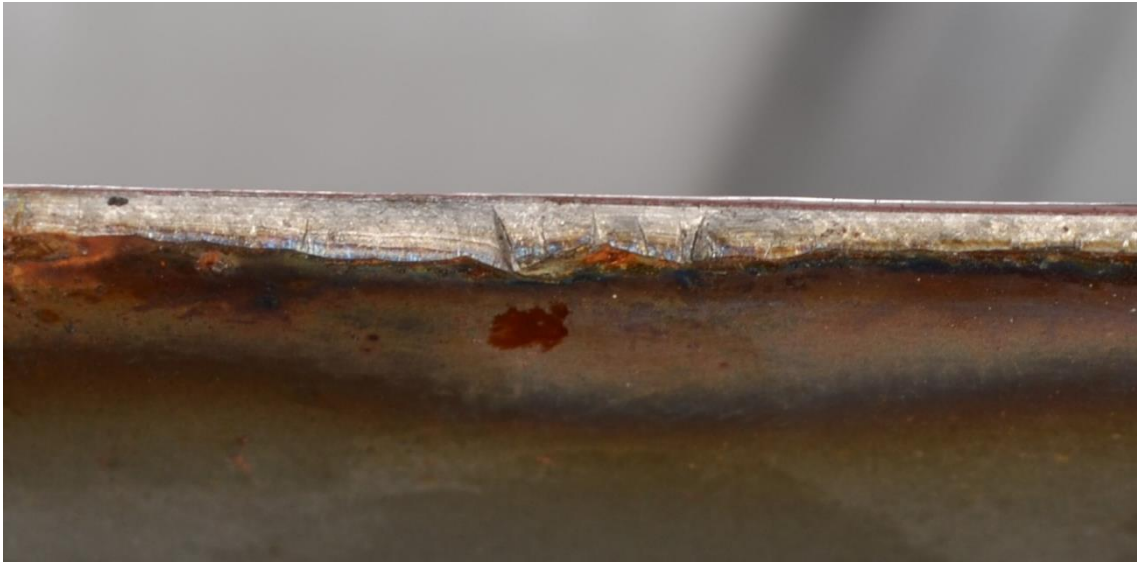
The throat of the weld should be at least the thickness of the parent plate and a fast travel speed is required to avoid melt-through to the inside corner. However, a fast travel speed is likely to result in a lower heat input per millimetre and a faster cooling of the joint which can then trigger solidification cracking. The torch angle should bisect the angle formed by the two pieces of metal to be joined in order to apply equal heat to both sides of the joint. As can be seen in Figure 2, the heat input does not appear to be uniform in the two sides of the joint and this has led to the sharp lack-of-penetration defect, associated weld root undercut and the resultant solidification cracking from a combination of high joint restraint and fast cooling (Figure 4).

Figure 4 The fracture surface showing evidence of blue and straw temper colours, proving that the crack originated as a hot crack during solidification.

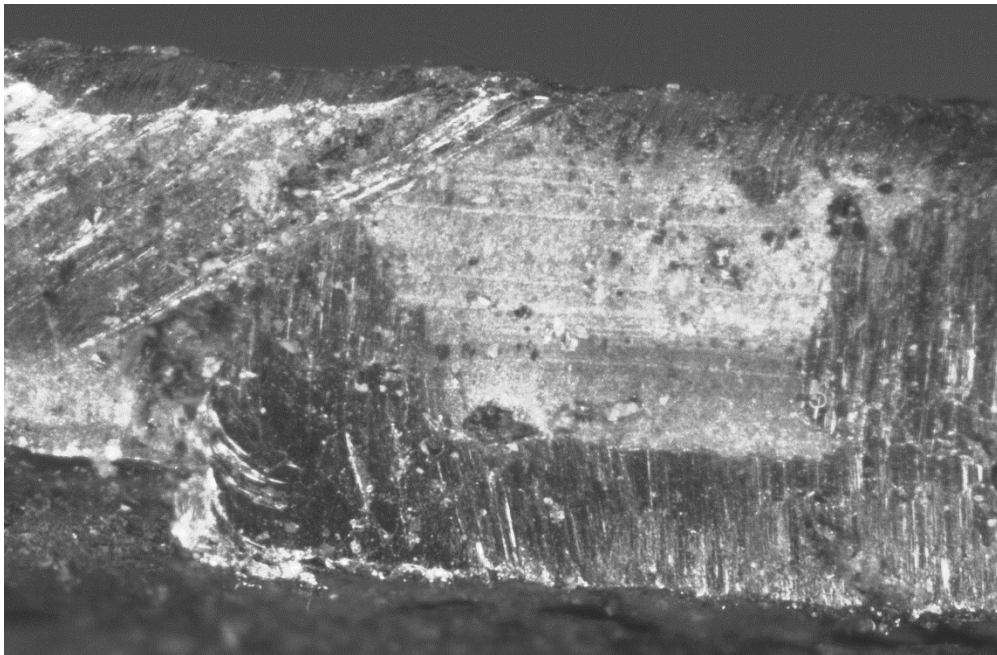
Part of the fracture surface containing the original through-thickness crack (indicated by screwdriver damage on the fracture surface – Figure 5) was sectioned from the larger specimen, cleaned and mounted for fractographic examination with stereo binoculars and with a scanning electron microscope. Low magnification inspection using stereo binoculars showed that a number of beachmarks were present both in the region of the initial water leak (Figure 5) and more generally along the fracture (Figure 6). The considerable number of beachmarks through the thickness indicates that their formation cannot be due only to a change in fracture mechanism from the pre-existing solidification crack to subsequent fatigue crack growth and/or fast fracture.

Figure 5 Beachmarks present on the fracture surface at the site of the original water leak, whose position was identified from the surface damage (seen here) inflicted by insertion of the screwdriver.

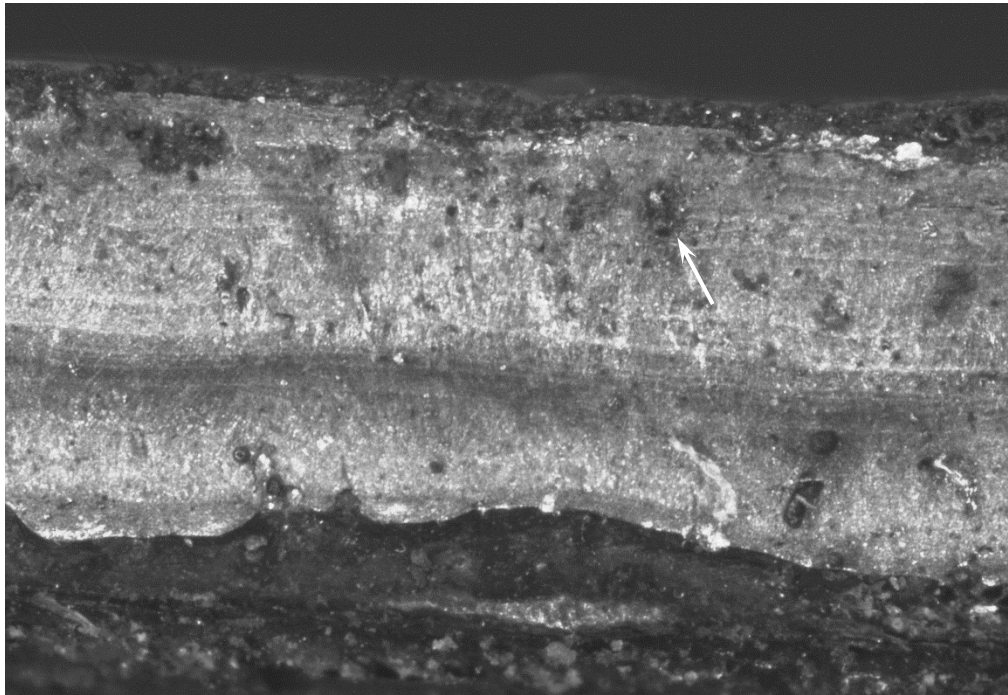
Figure 6 The beachmarks were present all along the fracture surface and therefore reflect influences other than mechanism changes.

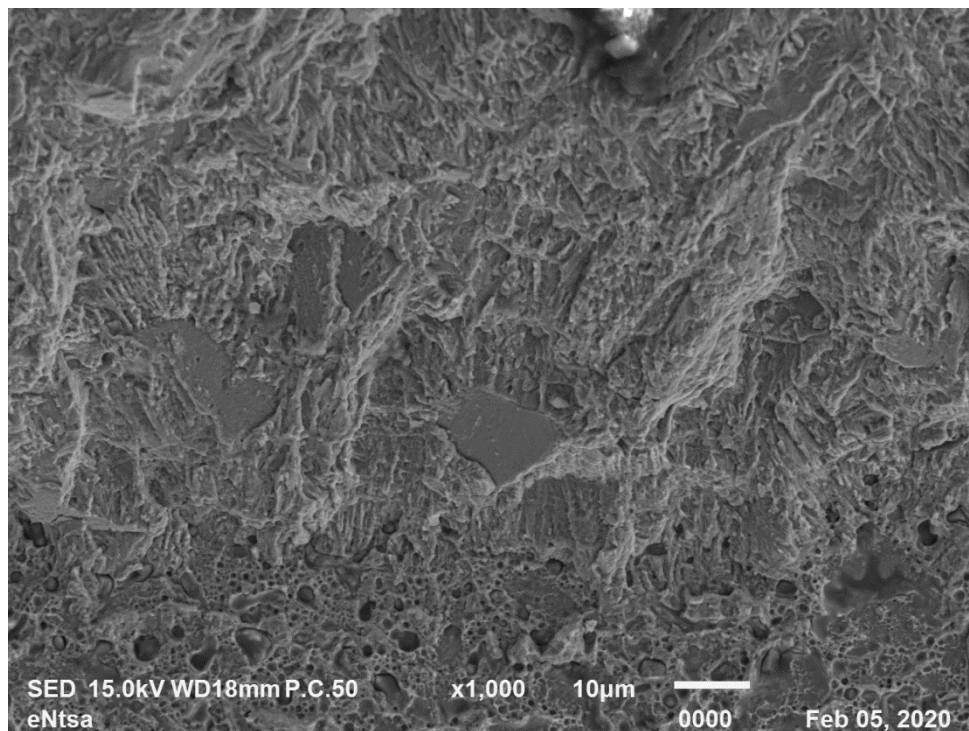
A fatigue mechanism is believed to have caused crack extension through the seam weld thickness during delivery of the water tank to the customer. The tank is never completely filled with water and will experience slosh during the delivery journey, while the very sharp weld toe intrusion crack would require only small applied stresses to grow. It is also possible that a resonance problem existed, where a natural frequency of the tank coincided with the frequency of road-induced vibration. In this respect Figure 9 shows the transition from the initial solidification defect to a fracture mechanism that is typical of slow fatigue crack growth in 300 series austenitic stainless steels, where occasional intergranular facets reflect an environmental component to crack growth e.g. [14].

Figure 9 Transition from the initial solidification crack to a region that has an appearance typical of slow fatigue crack growth in 300 series austenitic alloys.

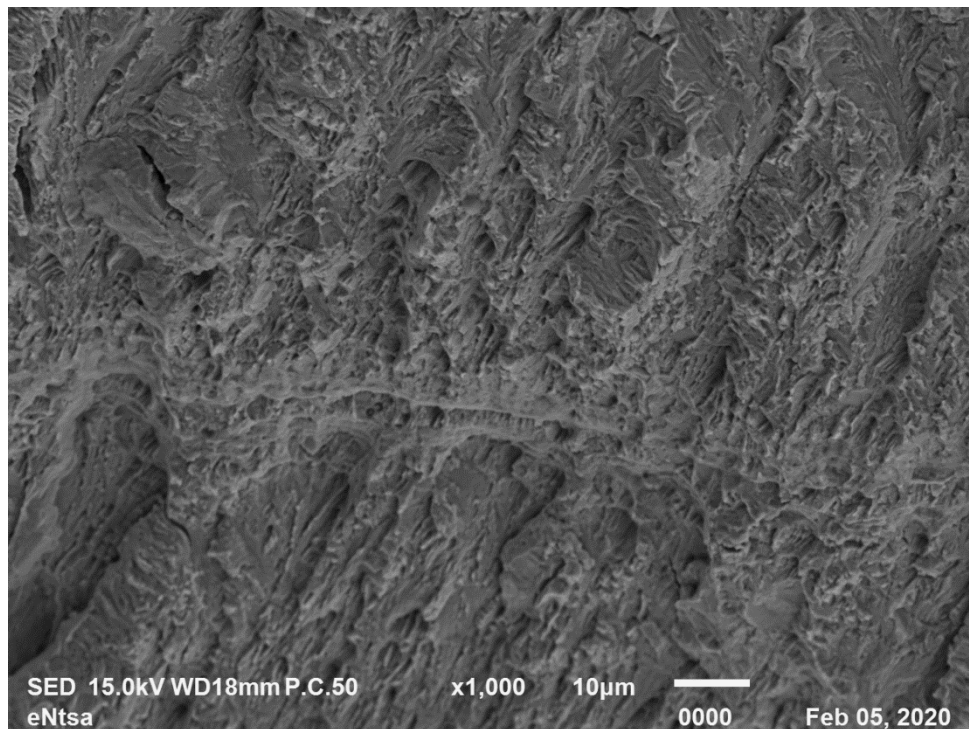
Moving further from the root of the weld, Figure 10 indicates that the fracture surface mechanism changes to one that represents brittle interdendritic fracture, with the possible origin being loads arising from liquid slosh during heavy braking or accelerating, or from significant irregularities in the road surface, e.g. potholes. The beachmarks on the fracture surface (Figures 5 and 6) can therefore be ascribed to a sequence of changes from one interdendritic interface to another. This is proposed to be a result of microfissuring in the interdendritic regions opening up into a crack under strains induced during transportation of the tank [2]. This interdendritic mechanism is clearly seen in Figure 11 at higher magnification and was also the mechanism involved in the crack extension when the screwdriver was inserted into the original crack.

The crack extension from insertion of a screwdriver into the initial leaking fissure reflected the extensive interdendritic solidification microfissuring across the throat of the weld (Figures 10 and 11).

Figure 10 Brittle interdendritic fracture comprises the bulk of the fracture surface, reflecting microfissuring that opens up into a macro-crack under applied strain.

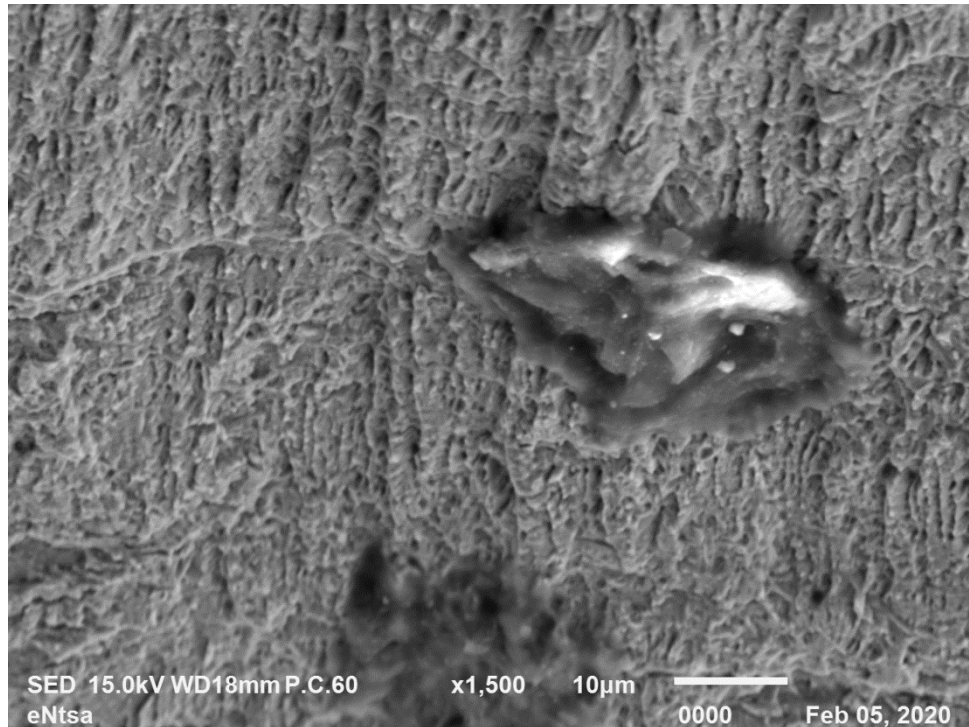
Figure 11 The mechanism of interdendritic fracture can be clearly seen in this image.

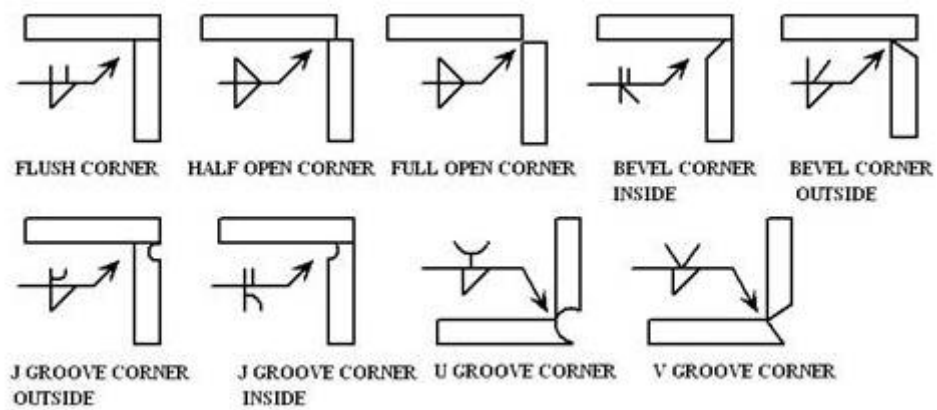
Guidance on GTAW of common welded joints is widely available on the internet, e.g. [15] and the full-open or half-open corner joint that was used for the failed seam weld (illustrated in Figure 12), although simple, requires some attention in terms of fit-up. According to the guide in reference [15] open corner joints demand precise fixturing because of the shallow joint depth and the ease with which the edge of the material melts. Stainless steel open corner joints are particularly susceptible to warping and tack welds may be required at a spacing ~50-75 mm in thin material to maintain a consistent joint. There was no evidence of such tack welds being used in the present case.

Figure 12 Types of corner joint edge preparation, illustrating the full-open or half-open corner joint that was used for the failed seam weld

A change in welding practice should resolve this problem, although a redesign of the tank could also be undertaken utilising, for example, rolled plate with a single butt weld joint and a flanged approach to attaching top and bottom pieces. These could then be either bolted or employ an edge weld on the flanged corner.
